# Manhole Inspection Summary

Manhole # S51AA\_027MH

Insp Date: **7/17/08 1:40 PM**

**Location** Address: **638 n streeper st**

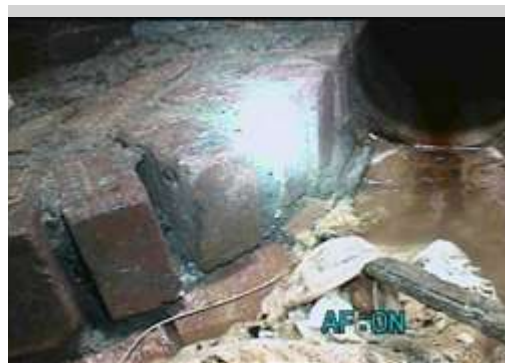
Defect 5

Condition: ☐ Sound ☐ Cracked ☐ Root Intrusion ☐ Deteriorated ☐ Leaks ☒ **Debris**

bench debris

channel debris

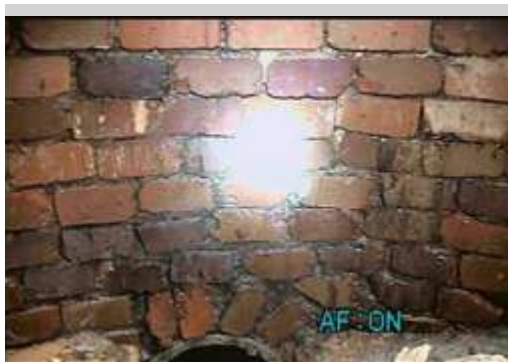
Defect 3

Infiltration: ☐ None ☐ Joint ☐ Cracks ☒ **Mortar** ☐ Roots ☒ **Wall**

mortar & wall infiltration in barrel

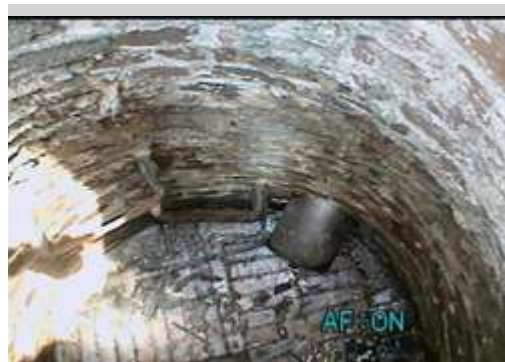
Defect 2

Count: **4** Missing: **2** ☒ **Corroded**

corroded, missing steps

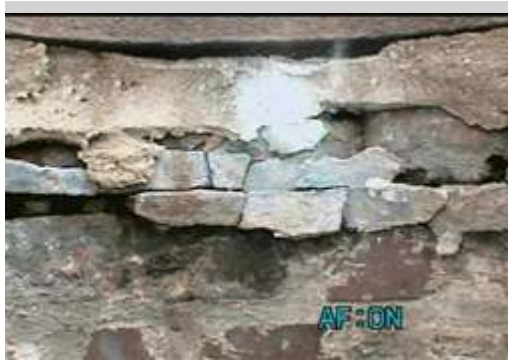
### Defect 1

Condition: ☐ Sound ☒ **Cracked** ☐ Root Intrusion ☒ **Loose Brick** ☒ **Deteriorated**

chimney cracked, loose bricks,  
deteriorated
